HOW MUCH SHOULD BE REPLACED AT THE SAME TIME AS YOU REPLACE THE STAIR TREADS?

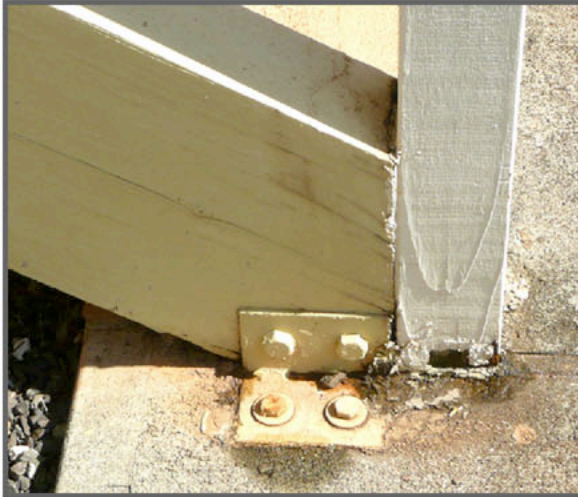
Above post & stringer clearly needs replacement. This may be one of the few in the project that needs such major work. (next time, put brackets on the inside.)

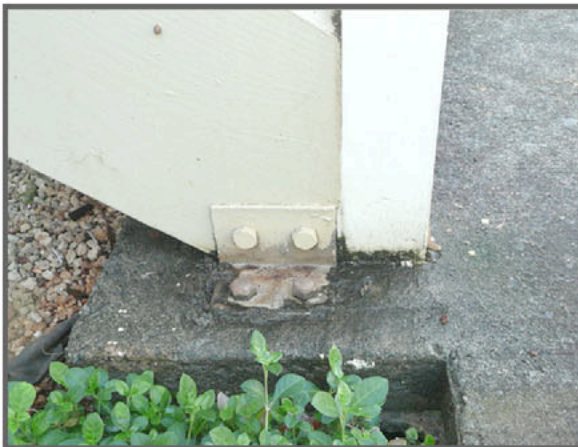
Above is typical of generally well-maintained stringers and posts in the same project as top. When tapped or poked, they sound solid, so probably don't need replacing. Water hasn't wicked up from the slab and done more than cosmetic deterioration, so treat at the same time the stair treads are replaced. Some angles may have to be replaced, but not these.

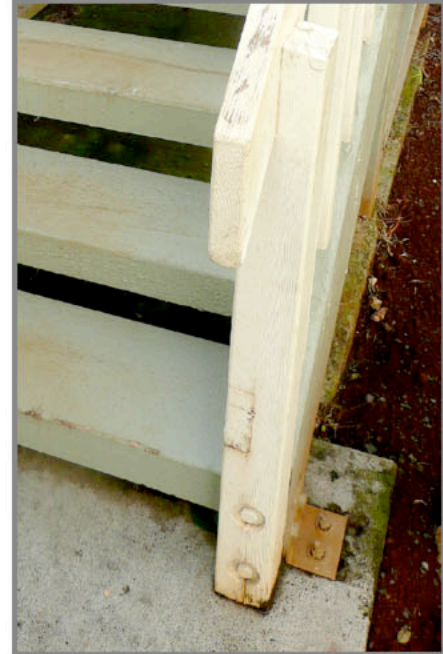
Above is "Before" at a different Waipio condo, but same original builder. These posts and stringers had deteriorated to the point they all needed replacing.

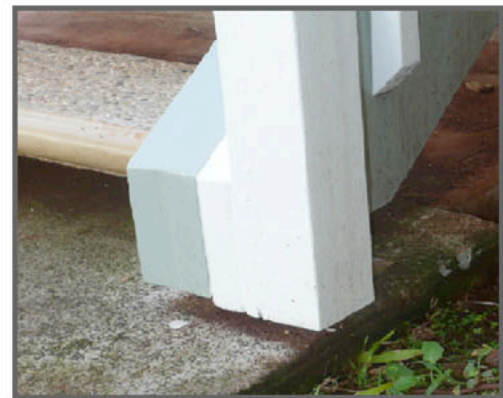
Below is "After", with new posts and stringers suspended on treated brackets. Is this overkill? The fastening method at left has lasted 20 years.
