STEPTREAD Job TOUR

Nuuanu Streamside

Here's **NUUANU STREAMSIDE**, at 1649 Waikahalulu Ln, Nuuanu, Honolulu.

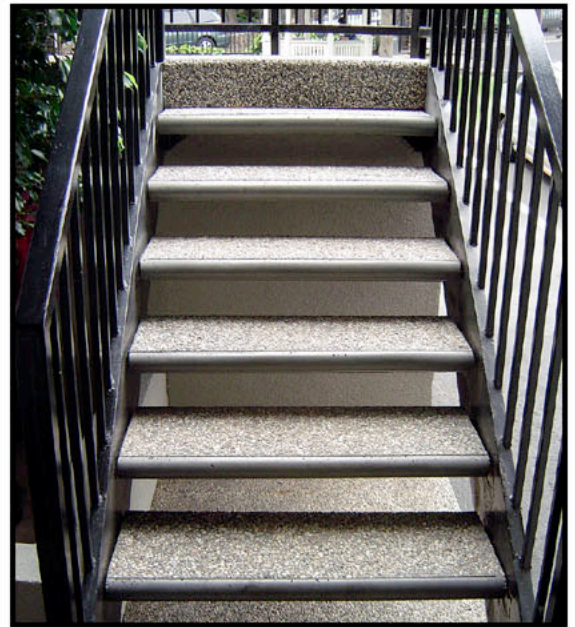
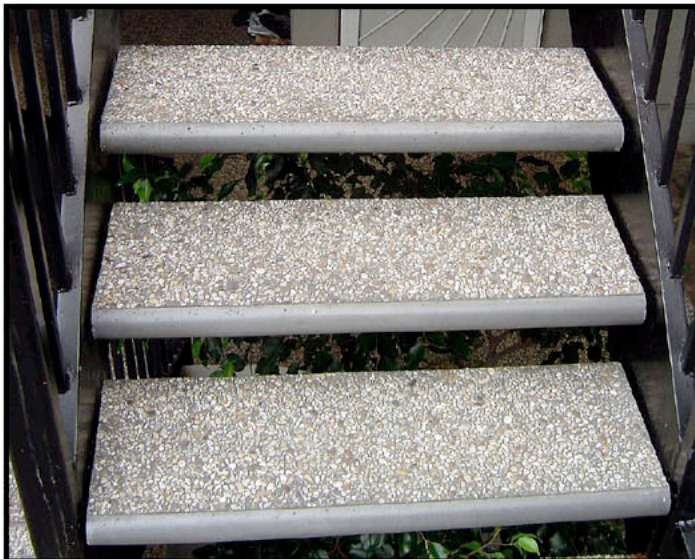
A close-up of the French Gray STEPTREADS, in our Del Rio exposed aggregate. (Hawaiian Texture wasn't an option back then . . .)

Previous treads were steel pans filled with concrete, which had spalled due to water filling the pans & rusting out. They were torched out, and replaced with Precast Concrete STEPTREADS which *Can't Rust!*

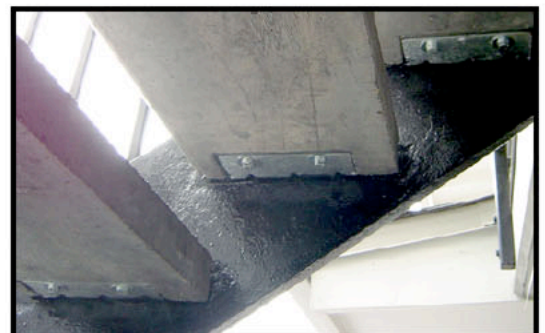
Existing steel channels were repainted. See below for view from bottom, with our special galvanized angles welded to the channels, then the STEPTREADS bolted to the angles. A laborer can do this final step of the installation, rather than another day charged by a welder.
